Report 07-005	Raytheon 1900D, ZK-EAN and Saab-Scania SF340A, ZK-FXA,	29 May 2007
INCORPORATING	critical runway incursion, Auckland International Airport	
Report 07-009	Raytheon 1900D, ZK-EAH and Raytheon 1900D, ZK-EAG,	1 August 2007
	critical runway incursion, Auckland International Airport

**Raytheon 1900D, ZK-EAN and
Saab-Scania SF340A, ZK-FXA**

critical runway incursion

Auckland International Airport, 29 May 2007

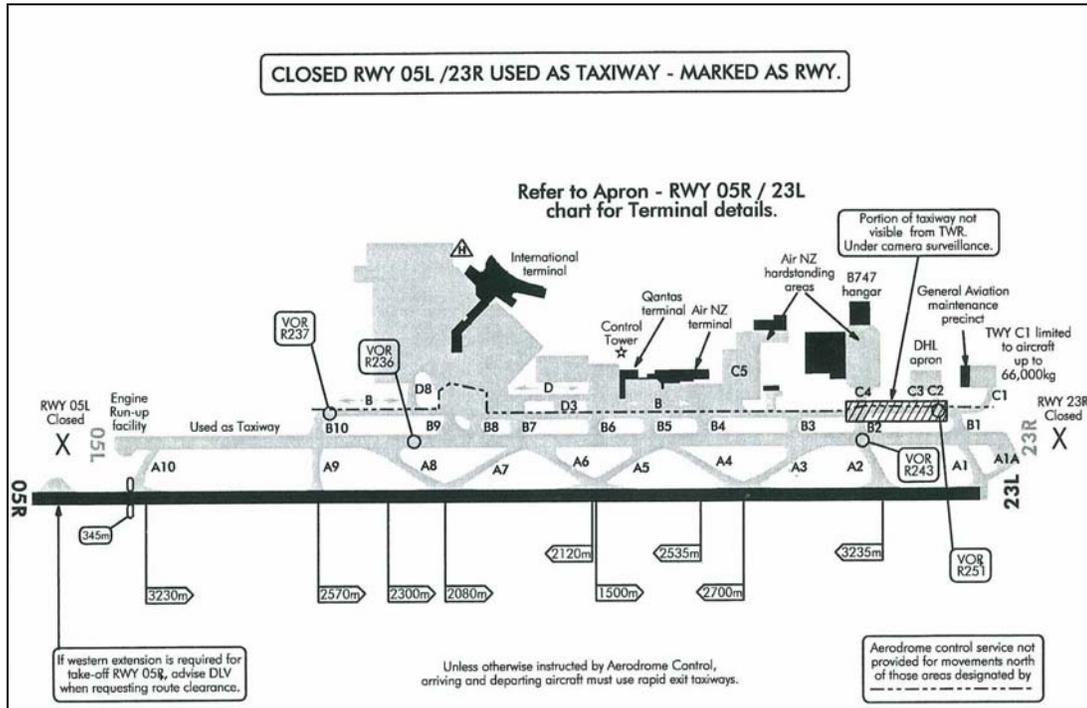
Figure 1
Auckland International Airport plan

1.1.1 On the afternoon of 29 May 2007, runway 23 left (23L)² was in use at Auckland International Airport (see Figure 1). The 4 ATC staff in the tower, employees of Airways New Zealand (Airways), included an aerodrome controller responsible for aircraft on the runway and in the air within the control zone, and a ground controller responsible for aircraft movements on the rest of the manoeuvring area.³

Aeronautical Information Publication stated, “Unless otherwise instructed by Aerodrome Control, arriving and departing aircraft must use rapid exit taxiways” (see Figure 1).
