**FINAL INVESTIGATION REPORT ON
INCIDENT TO M/s AIR INDIA LTD. AIRBUS A320 AIRCRAFT
VT-ESE, ON 04.10.2017 AT SURAT.**

**OFFICE OF DIRECTOR OF AIR SAFETY (WESTERN REGION)
GOVERNMENT OF INDIA
Mumbai 40099**

1	Aircraft	Type	AIRBUS A320-231
		Nationality	INDIAN
		Registration	VT-ESE
2	Owner & Operator	M/s AIR INDIA LTD.	
3	Pilot – in –Command	ATPL	
	Extent of injuries	NIL	
4	Date & Time of Incident	04.10.2017 / 0146 UTC	
5	Place of Incident	VASU (Surat Airport, Surat)	
6	Co-ordinates of Incident site	N 21 07.0 ; E 072 44.5	
7	Last Point of Departure	VIDP (Indira Gandhi International Airport, Delhi)	
8	Intended place of landing	VASU (Surat Airport, Surat)	
9	No. of Passengers on board	145	
10	Type of Operation	Scheduled Revenue Flight	
11	Phase of Operation	Landing	
12	Type of Incident	Runway excursion

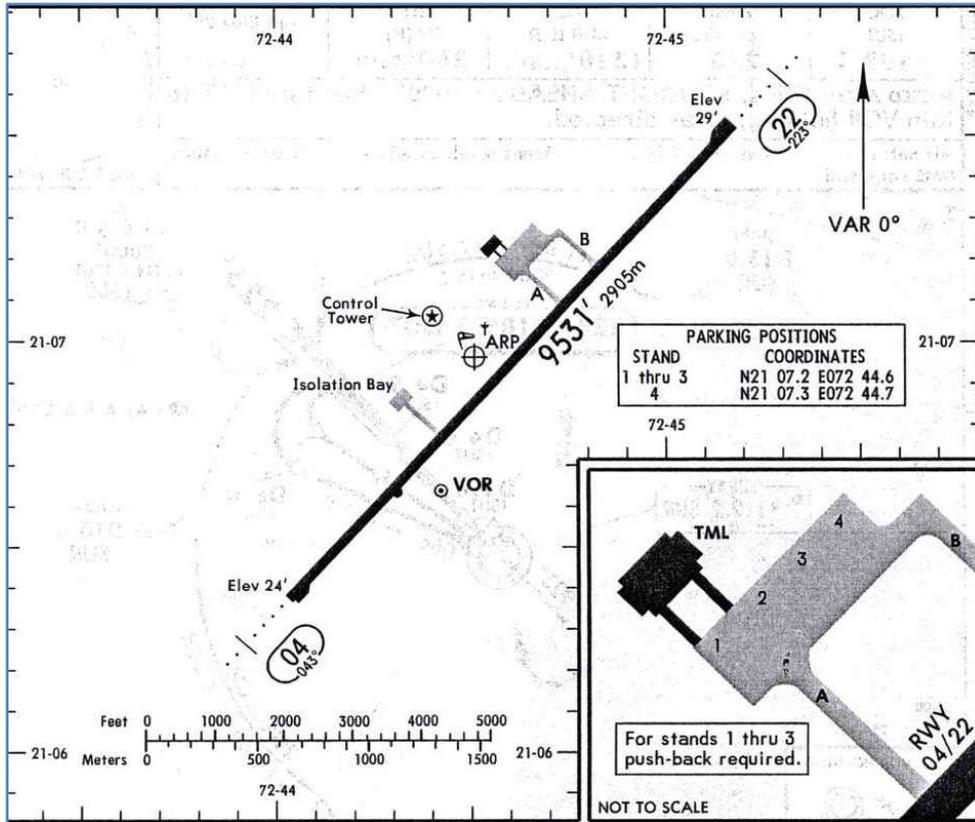
Figure B: Aerodrome chart VASU (Surat Intl Airport)

The declared distances due displacement of threshold of runway 22 is as below:
