FINAL REPORT

**AIRBUS A380-800, REGISTRATION 9V-SKA
PUSHBACK INCIDENT IN SINGAPORE CHANGI AIRPORT
10 JANUARY 2008**

AIB/AAI/CAS.046

**Air Accident Investigation Bureau of Singapore
Ministry of Transport
Singapore**

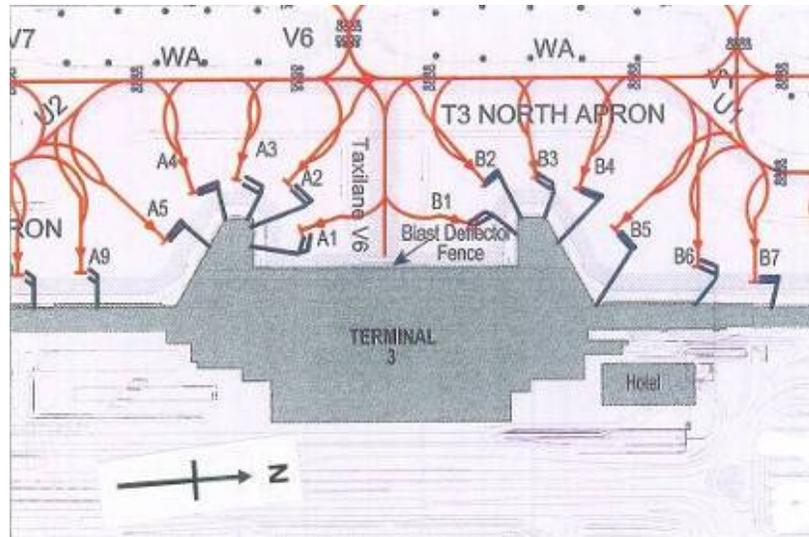
1.1.1 The aircraft was scheduled to operate a passenger flight to Sydney. The aircraft was parked at Bay A4 (**Figure 1**) in the new Terminal 3 which had commenced operation a day earlier.

Figure 1. Location of Bay A4

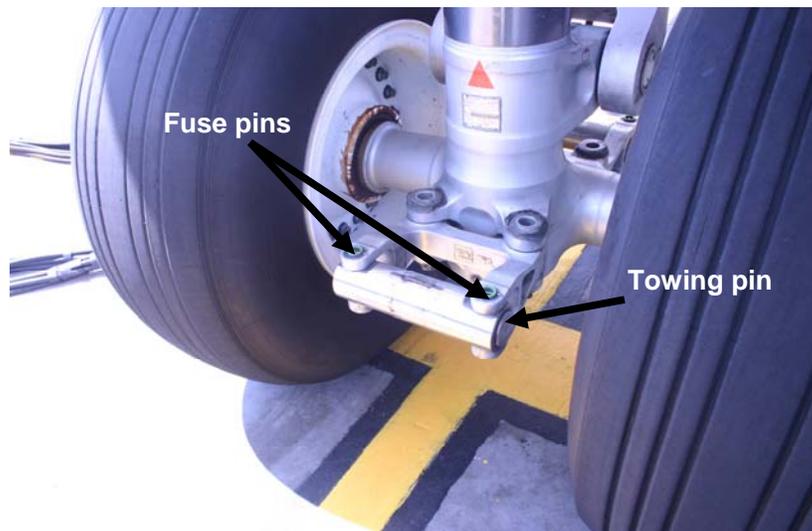
- 1.1.3 The driver tried to pull the aircraft out of the unpaved ground. During the pulling, the fuse pins attaching the towing pin¹ to the towing fitting on the aircraft nose landing gear (NLG) sheared (**Figures 3, 4 and 5**). Together with the tow bar, the towing pin was detached from the NLG and the aircraft was thus separated from the air tug. The aircraft was otherwise not damaged. Damage to the air tug is described in paragraph 1.2.

Figure 4. Nose gear towing fitting with fuse pins and towing pin in place

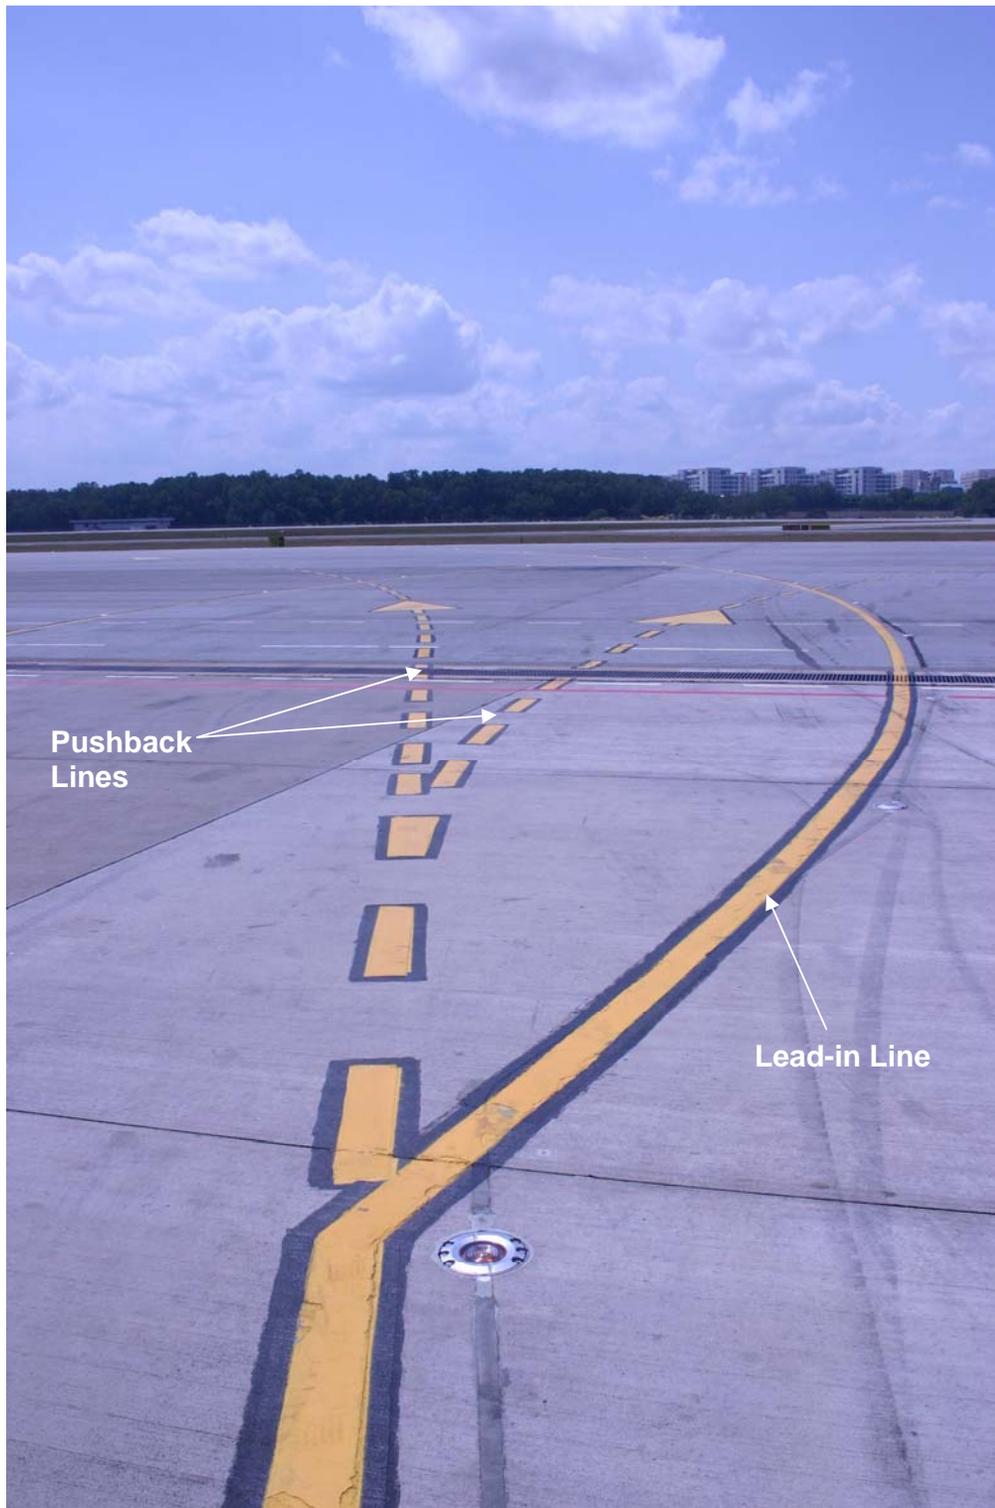
Pushback lines added to Bay A4 apron
