RESEARCH PAPER

# Australian Aviation Accidents Involving Fuel Exhaustion and Starvation

RESEARCH PAPER  
DECEMBER 2002

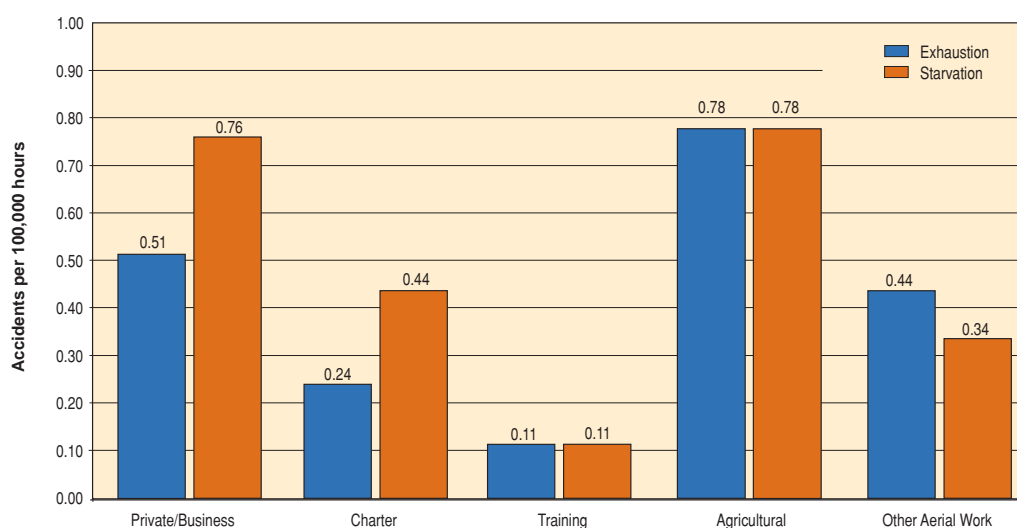
**FIGURE 1:**  
**Exhaustion and starvation accident rates by operational category (1991–2000)**

<sup>3</sup> Private and business operations are listed together in Figure 1 as the hours flown were not available for the two categories separately.

As can be seen, the agricultural category had the highest fuel exhaustion accident rate (0.78, or one accident every 128,205 hours flown); and the highest rate of fuel starvation accidents (0.78 or one accident every 128,205 hours flown). The private/business category experienced the second highest rate of both fuel exhaustion accidents (0.51 or one accident every 196,078 hours flown) and fuel starvation accidents (0.76, or one accident every 131,579 hours flown).

The actual rate of accidents per 100,000 flying hours for each operational category for the years 1991–2000, are presented in Figure 1.<sup>3</sup>

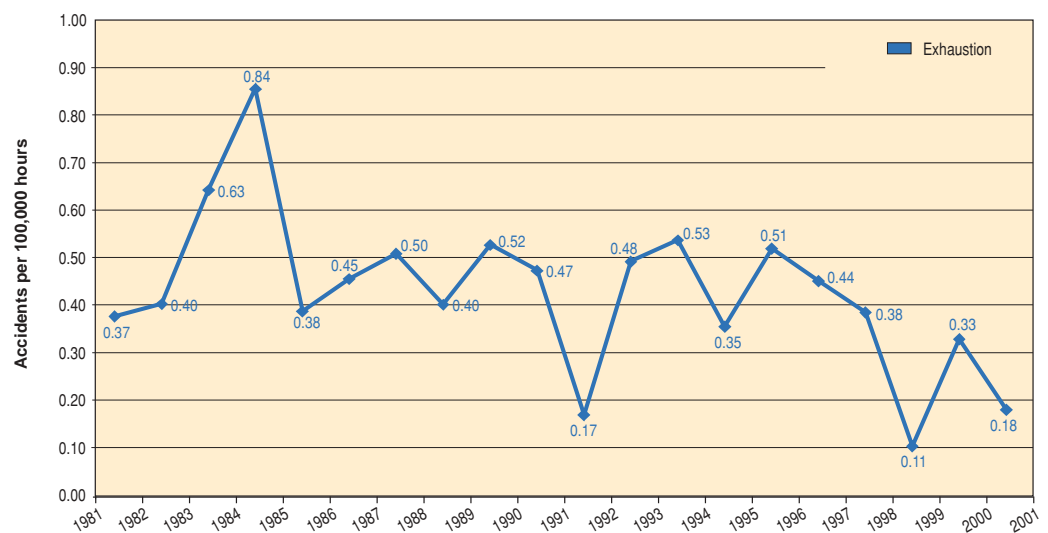
**FIGURE 2:**  
**Exhaustion accident rates (1981–2000)**

The Fuel Exhaustion graph (fig. 2) indicates a downward trend, which is especially apparent over the last five years (1995–2000). Analysis revealed this to be a significant trend.<sup>9</sup> The Fuel Starvation graph (fig. 3) indicates a relatively stable rate. Analysis of the data found no significant trend for starvation accident rates.<sup>10</sup>

Figures 2 and 3 illustrate the rate of fuel exhaustion and starvation accidents for GA within Australia between 1981 and 2000. These rates were calculated using the total number of exhaustion and starvation accidents which occurred each year, in conjunction with the total number of hours flown.

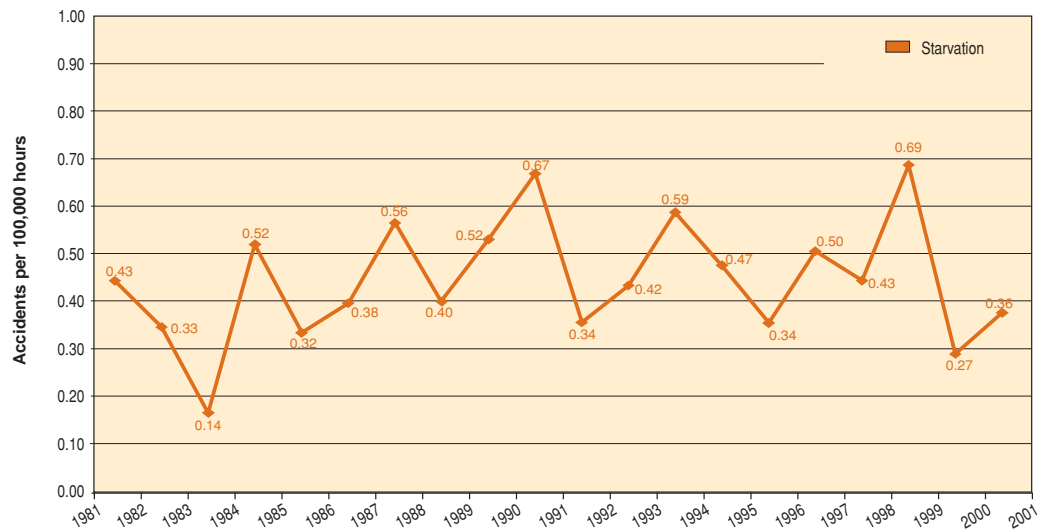
**FIGURE 3:  
Starvation accident rates (1981–2000)**

Statistical analysis of this data revealed no statistically significant change in fuel starvation accident rates.<sup>11</sup> The analysis also revealed that fuel exhaustion accident rates between 1991 and 2000 were significantly lower than those between 1981 and 1990.<sup>12</sup> Figure 3 indicates that this decrease may have occurred toward the end of the 1990's.

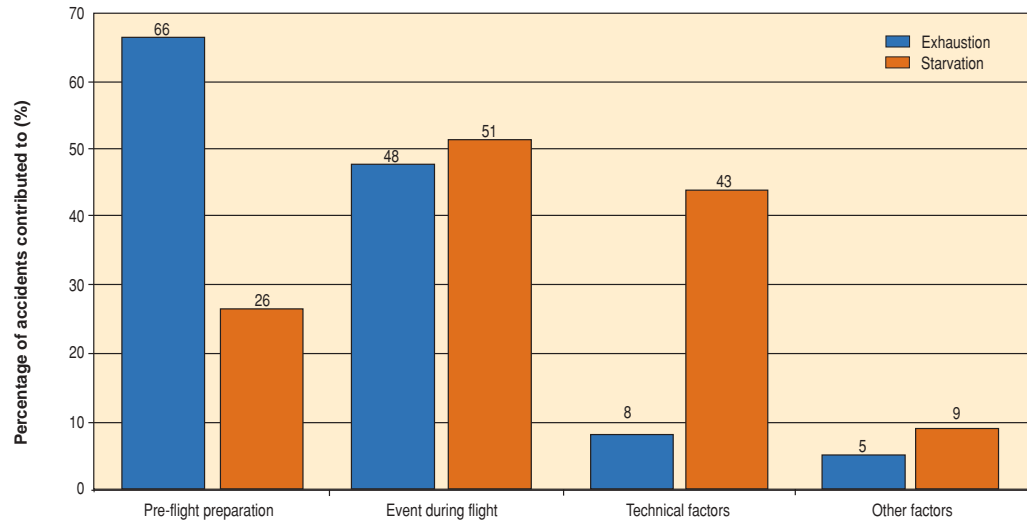
**FIGURE 4:**  
**Exhaustion and starvation accidents by contributing factors (1991–2000)**

As can be seen from the graph, Pre-Flight Preparation is indicated in the majority of fuel exhaustion accidents (66 per cent), followed by Events During Flight (48 per cent). Alternatively, for fuel starvation accidents, Pre-Flight Preparation is indicated in a relatively minor number of accidents (26 per cent), while Events During Flight and Technical Factors are indicated in 51 per cent and 43 per cent respectively. These findings support those of earlier research.

Figure 4 indicates the percentage of accidents attributed to either Pre-Flight Preparation, Events During Flight, Technical Factors or Other Factors (see section 3 and appendix A for description). As each accident could be attributed to more than one contributing factor, the total percentages sum to more than 100 per cent.
