Do you *really* understand how your trim works?

Many do not, and why it matters.
Alex Fisher - GAPAN

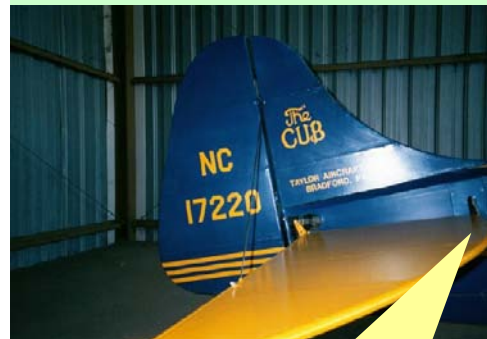
4. Trimming tailplanes aren't confined to the jets – this Piper Cub has one, as shown by the slot near the tailplane i.e. which provides access to the actuating link
