Final Report No. 1977 by the Aircraft Accident Investigation Bureau

concerning the serious incident (AIRPROX)
between EZY 9VM, B737-700, registration G-EZJG
operated by Easyjet
and PTI 747, B737 BBJ, registration HB-IIO
operated by Privat Air
on 11 May 2006
Geneva airport

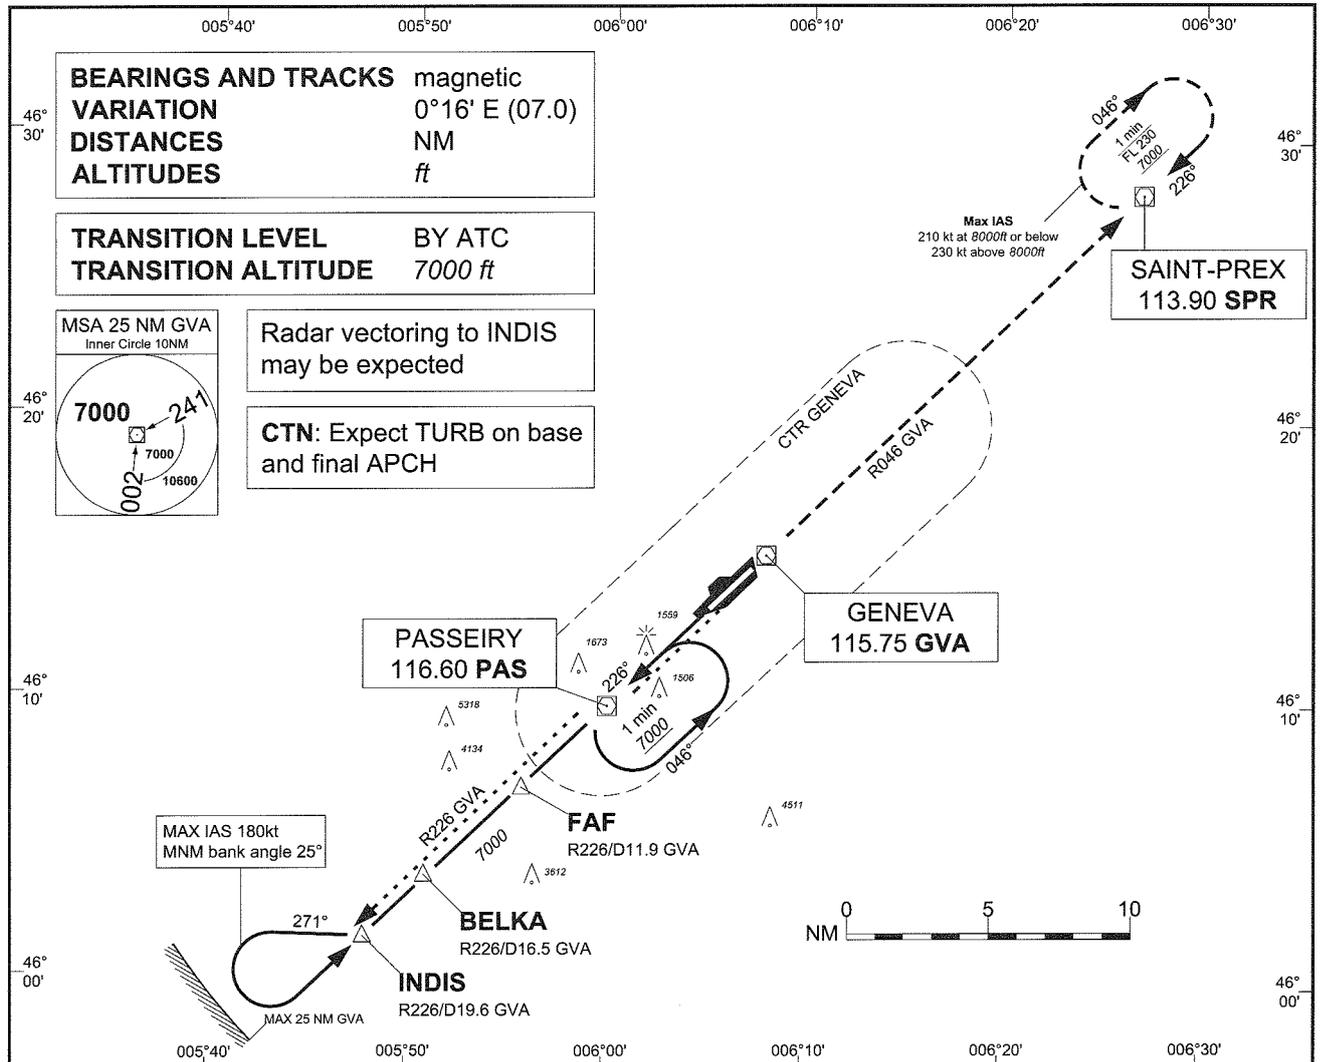
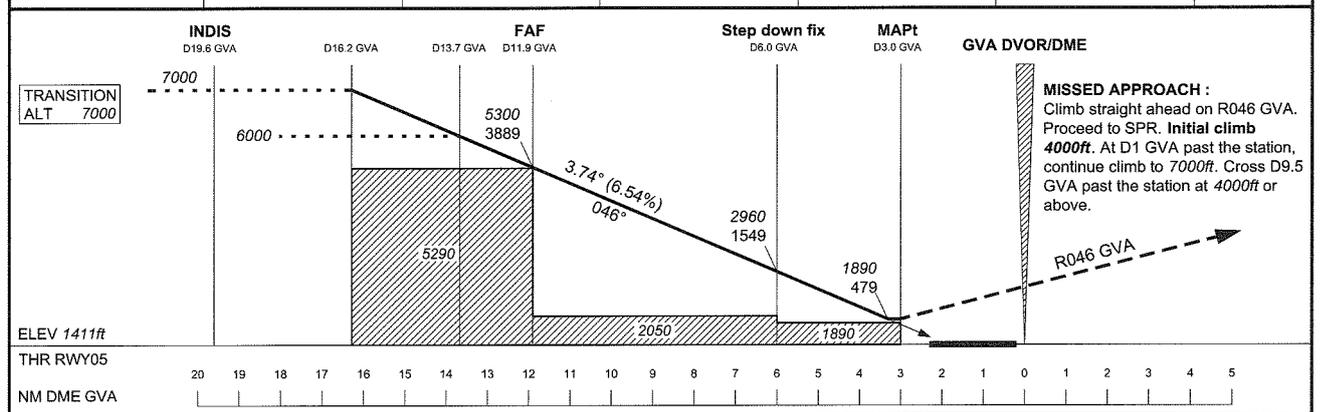
GENEVA
VOR RWY 05

OBSTACLE CLEARANCE ALTITUDE/HEIGHT (OCA/H)		A	B	C	D
Straight-in approach ¹⁾		1890 / 479			
Circling ²⁾	RWY05 and RWY23	2100 / 689		2400 / 989	
	GS kt	90	110	130	150
ROD	FT/MIN	596	729	861	993

- above THR elevation 1411ft, MAPt at 3 DME GVA (0.8 NM THR05).
- above aerodrome ELEV 1411ft, circling on assignment by ATC under special conditions and north of RWY only, speed and radius for category D as for category C aircraft.

GVA DME	RECOMMENDED CROSSING ALT/HGT
16	6930 / 5519
15	6540 / 5129
14	6140 / 4729
13	5740 / 4329
12	5350 / 3939
11	4950 / 3539
10	4550 / 3139
9	4150 / 2739
8	3760 / 2349
7	3360 / 1949
6	2960 / 1549
5	2560 / 1149
4	2170 / 759

It should be noted that the overflight of the PAS VOR should take place at an altitude of 3180 ft for an ideal slope of 3° (ILS). According to the radar recordings, the Privat Air aircraft was at approximately 5000 ft.

- Runway 05 was in service.
- The runway 05 ILS was out of service because of technical work.
- The type of approach noted in the ATIS was of the VOR/DME type.
