Tailplane icing—too much data, not enough knowledge

Clear guidance and realistic training are key to avoiding inappropriate crew response when encountering in-flight icing.

By Don Van Dyke
ATP/Helo/CFII. F28, Bell 222

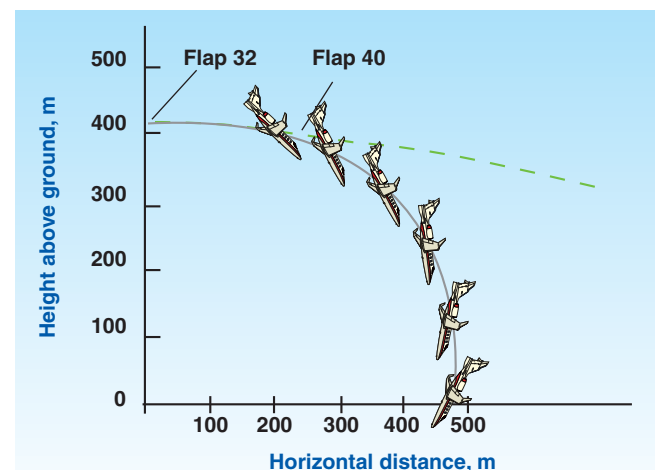
Illustration courtesy DGAC (France)

This diagram illustrates how severe nose-down pitch attitude and loss of control may become following tailplane stall.

Perhaps the most important characteristic of a tailplane stall is the relatively high airspeed at the onset and, if it occurs, the suddenness and magnitude of the nose-down pitch with the control column moving toward the forward limit. ICTS is more likely to occur when flaps approach full extension or during flight through wind gusts.
