Final Report No. 1983 by the Aircraft Accident Investigation Bureau

concerning the serious incident (AIRPROX)
between EZY 2076, B737, registration G-EZJL
operated by Easyjet
and KLM 57W, F100, registration PH-OFF
operated by KLM Cityhopper
on 29 December 2006
at Geneva Airport

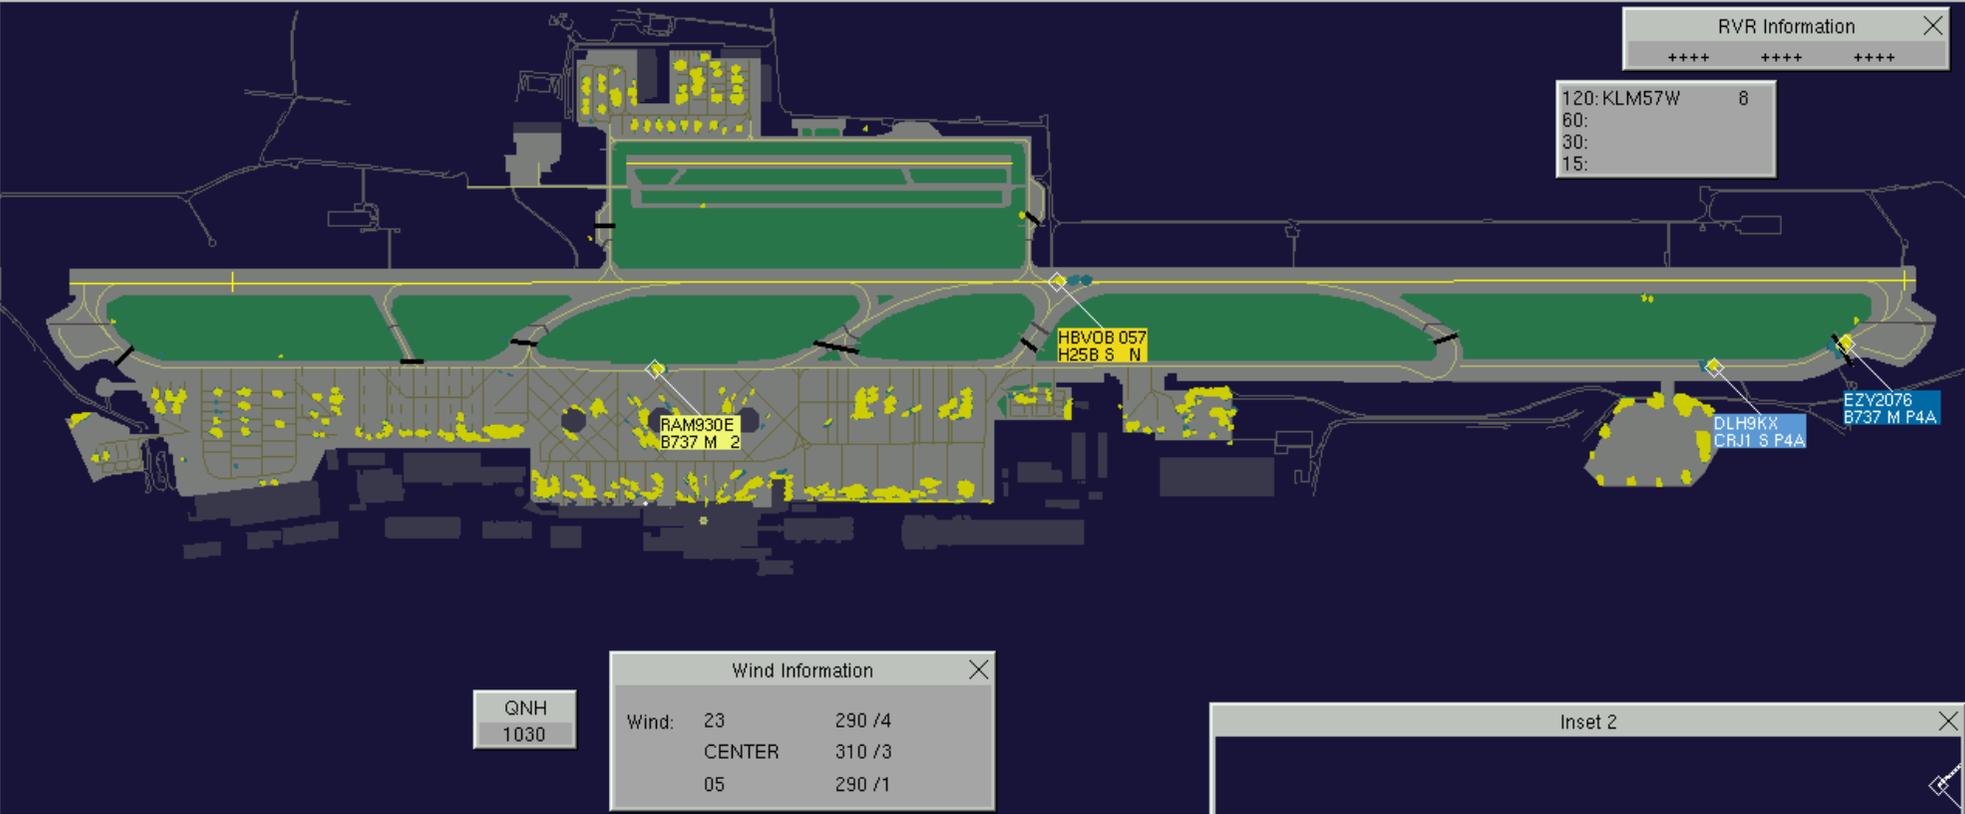
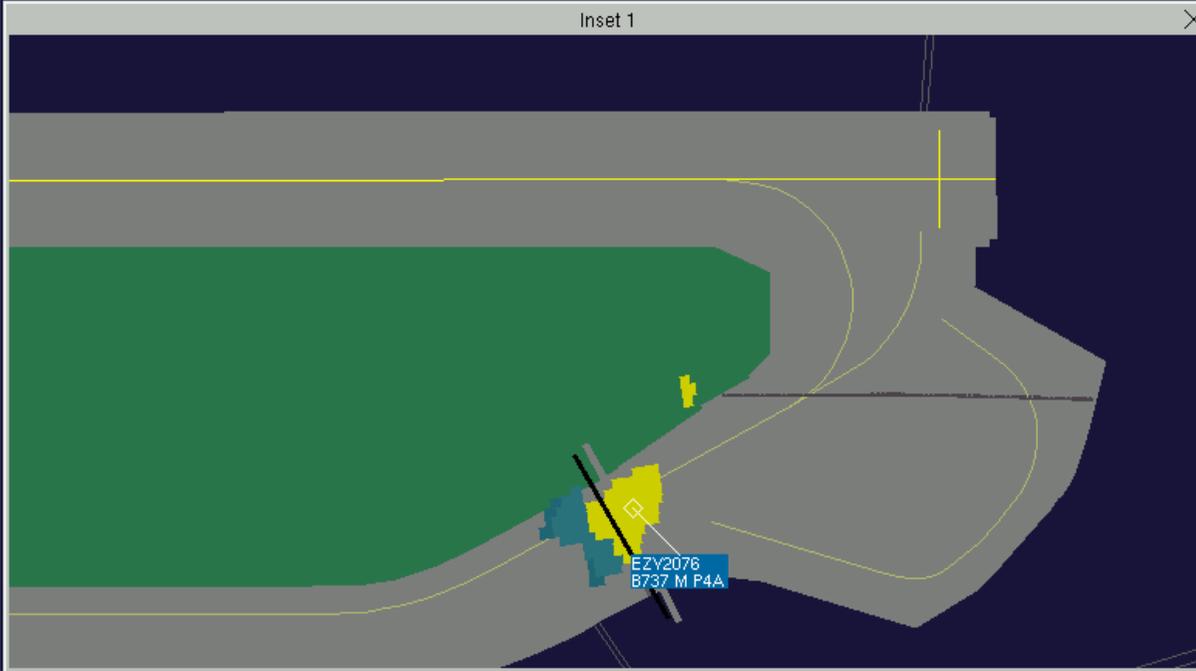
RVR Information
++++ +++++ +++++

120: KLM57W 8
60:
30:
15:

Wind Information
Wind: 23 290 /4
CENTER 310 /3
05 290 /1

QNH
1030

EZY2076
B737 M P4A

DLH5PH 208
AT72 084

AUA6GP 151
CRJ2 *059

KLM57W 156
F100 *031

Playback Info
Selected CWP: CWP-2
CWP data: Available
Role: TOWER
Speed: Pause
Mode: Interactive
