The 156-tonne GIMLI GLIDER

It's the 20th anniversary of aviation's most famous deadstick landing.

Merran Williams

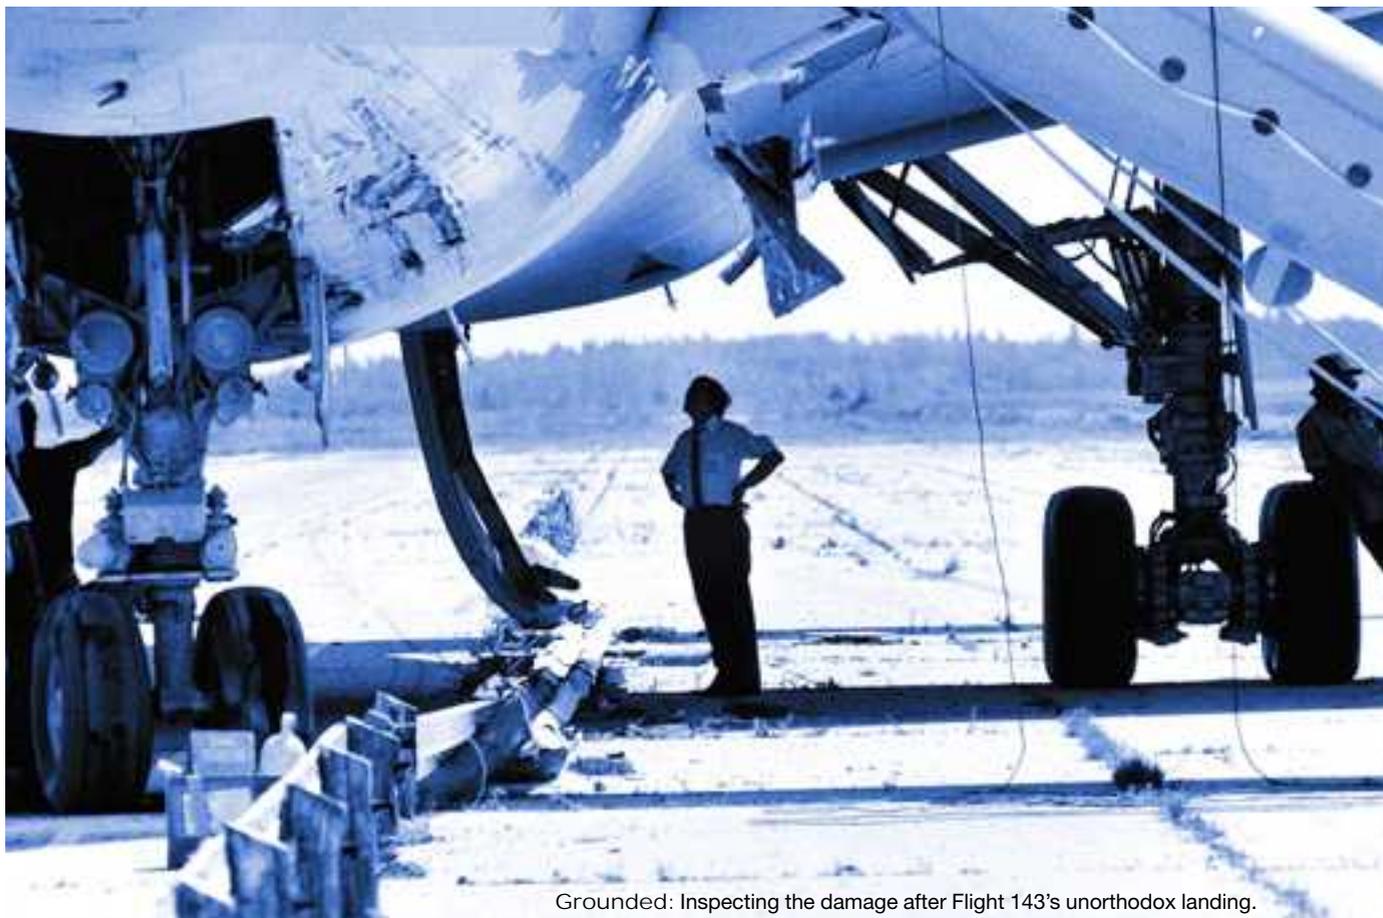
Grounded: Inspecting the damage after Flight 143's unorthodox landing.

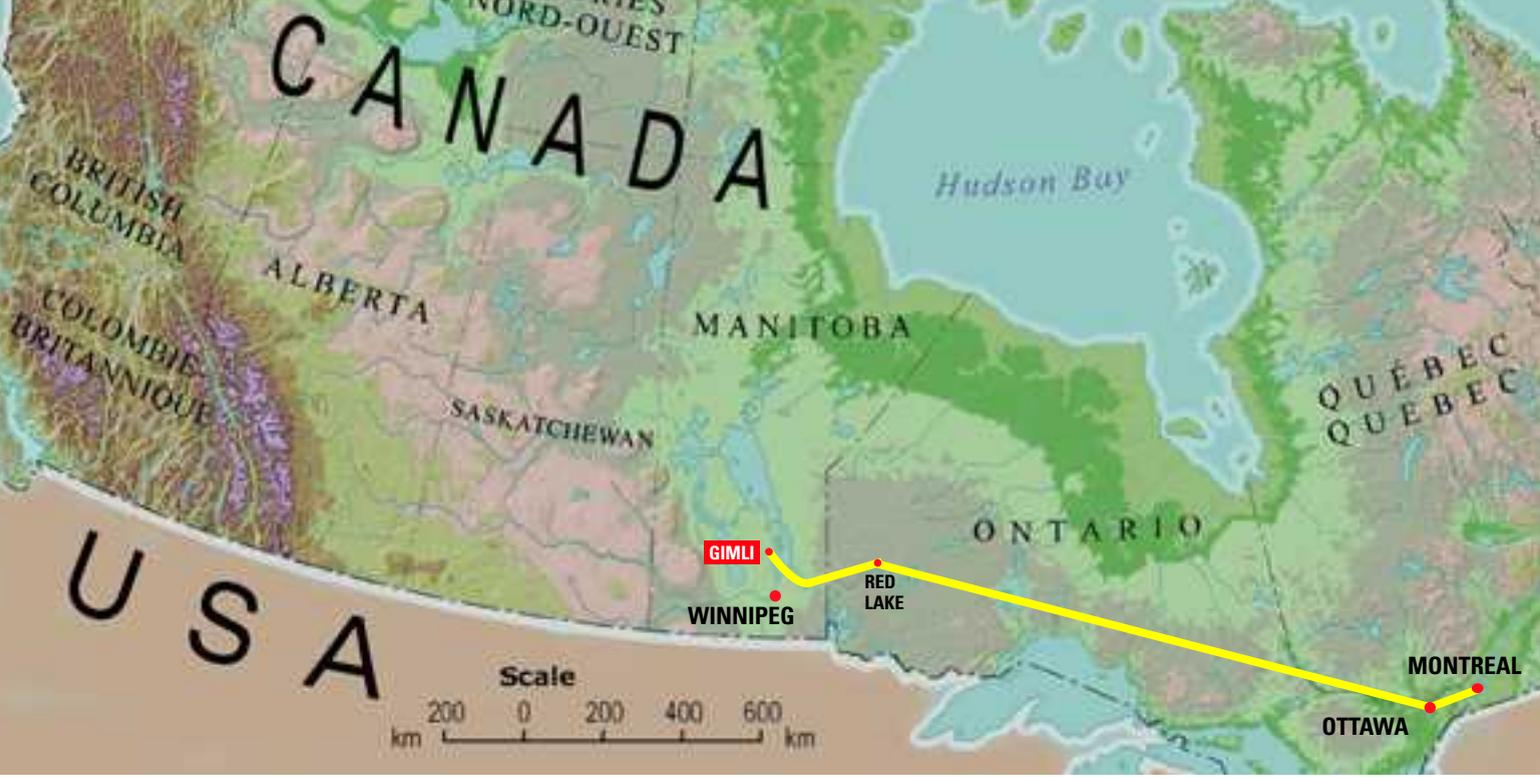
Cut short Travelling from Montreal to Edmonton via Ottawa, Flight 143 was forced to divert to Winnipeg because of a fuel shortage that led to the loss of both engines. When it became apparent the aircraft would not reach Winnipeg, the pilots changed course and headed to Gimli.

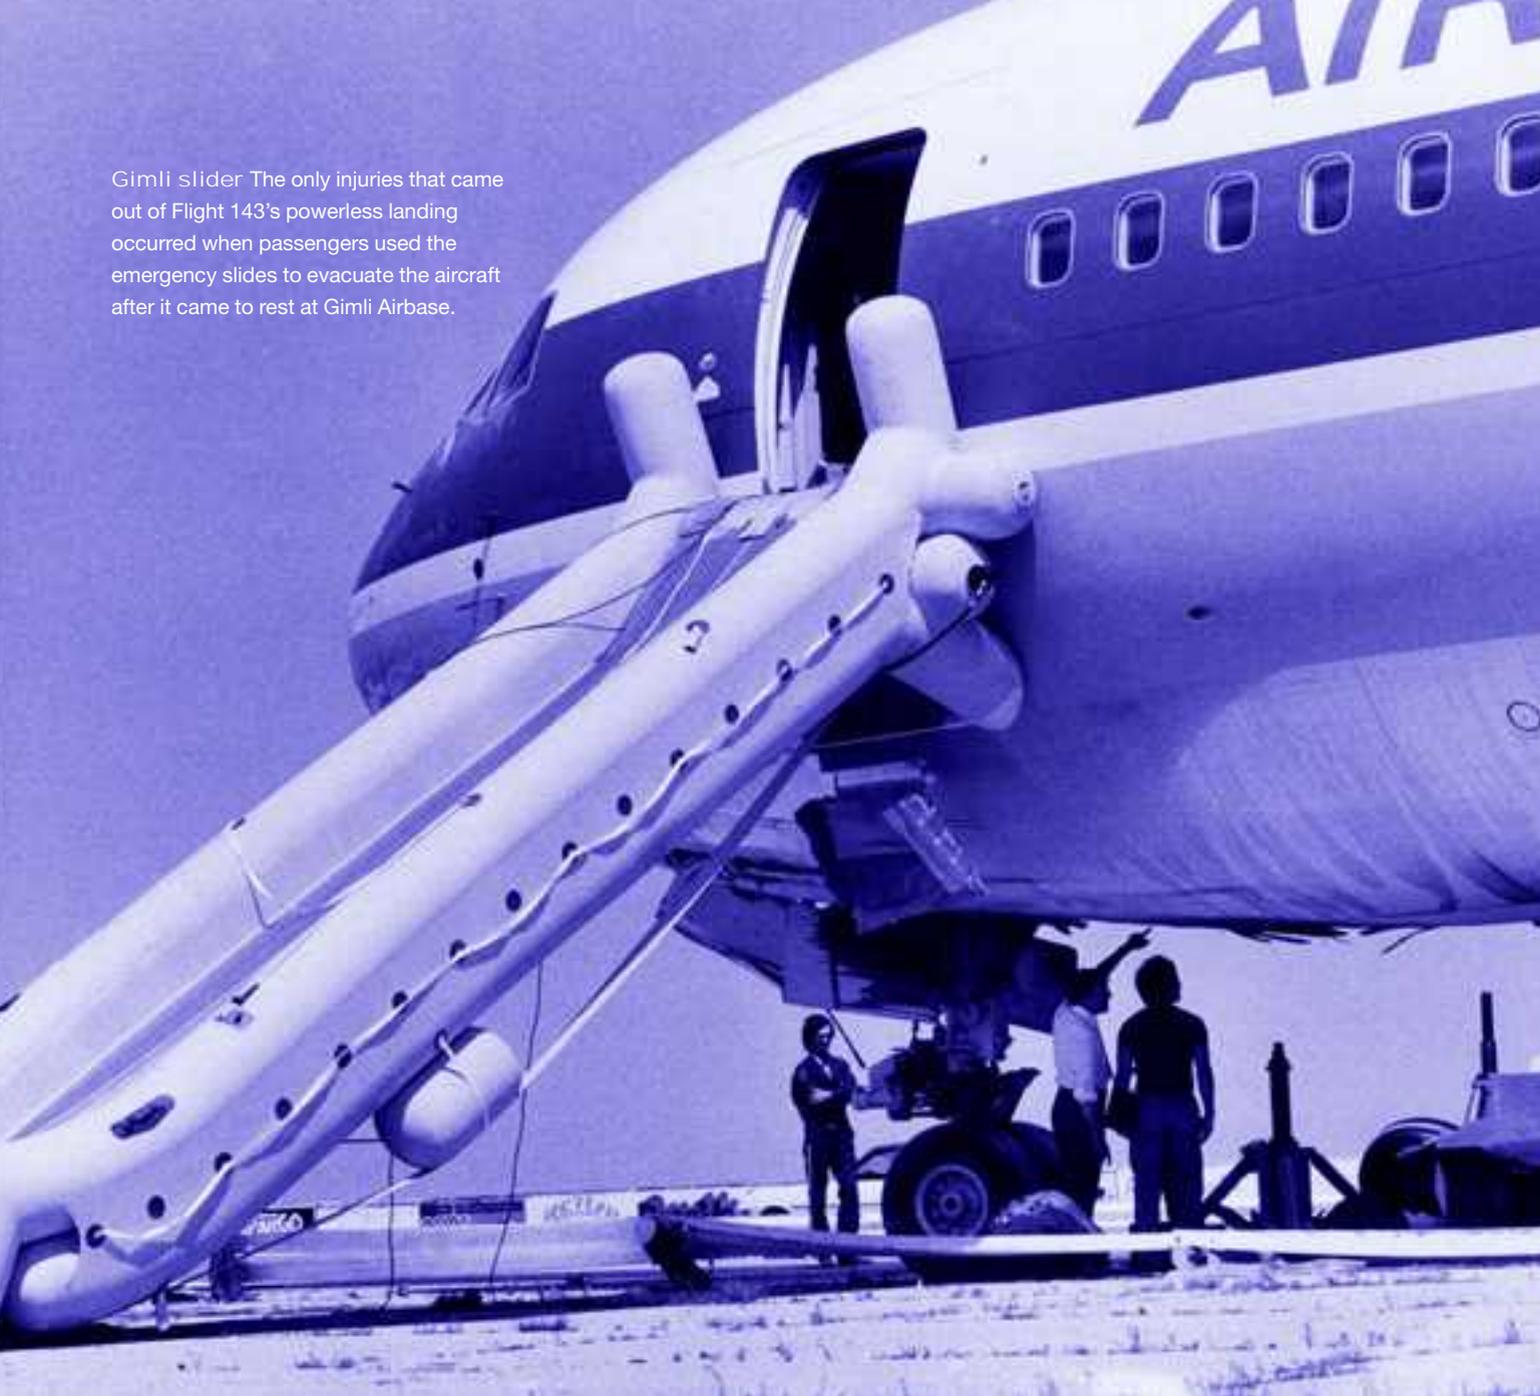
Gimli slider The only injuries that came out of Flight 143's powerless landing occurred when passengers used the emergency slides to evacuate the aircraft after it came to rest at Gimli Airbase.
